Technical Memorandum 33-733

*Single- and Dual-Carrier Microwave
Noise Abatement in The Deep Space Network*

JET PROPULSION LABORATORY
CALIFORNIA INSTITUTE OF TECHNOLOGY
PASADENA, CALIFORNIA

August 1, 1975

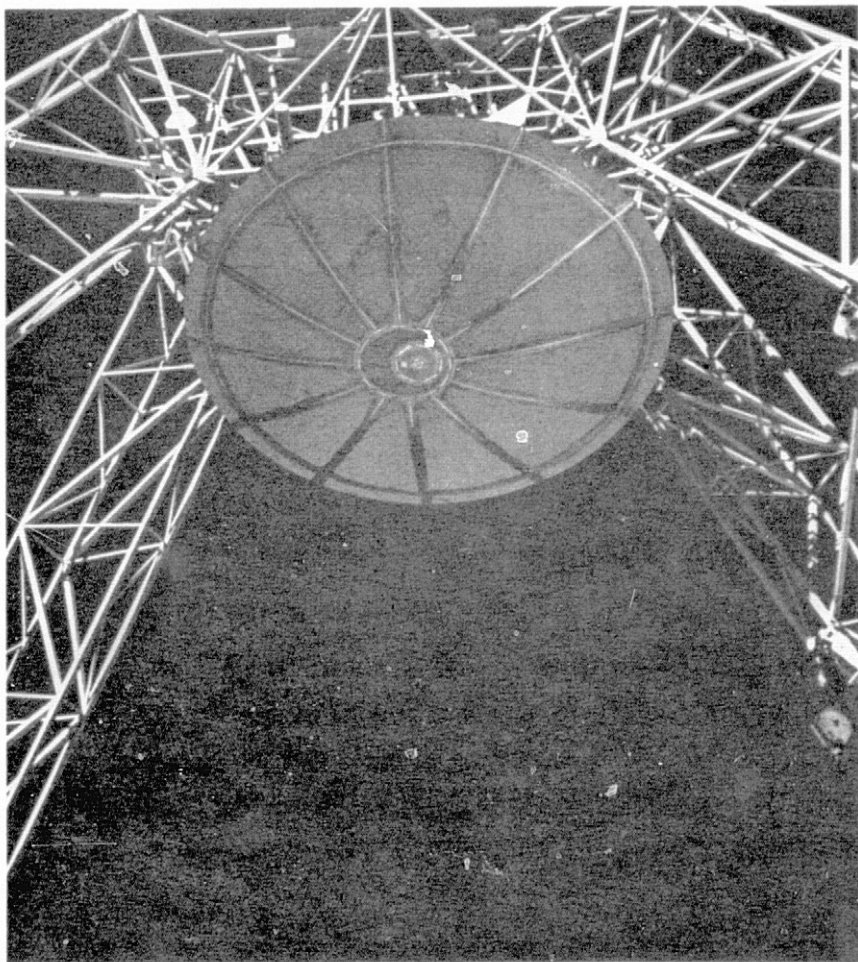
Figure 1. DSS 14 subreflector and apex region

Additional test data obtained at this time indicated considerable S-band leakage (on the order of -23 dB) through the DSS 14 Cassegrain subreflector panel seams despite the 50 mm-wide aluminum tape used to "seal" these

10. Subreflector panel joints improved using conductive epoxy along aluminum tape edges for positive (ohmic) bonding.
 11. Removed heavy loose stored subreflector hoist equipment at the quadripod apex to reduce vibration of the light-skinned subreflector surface.

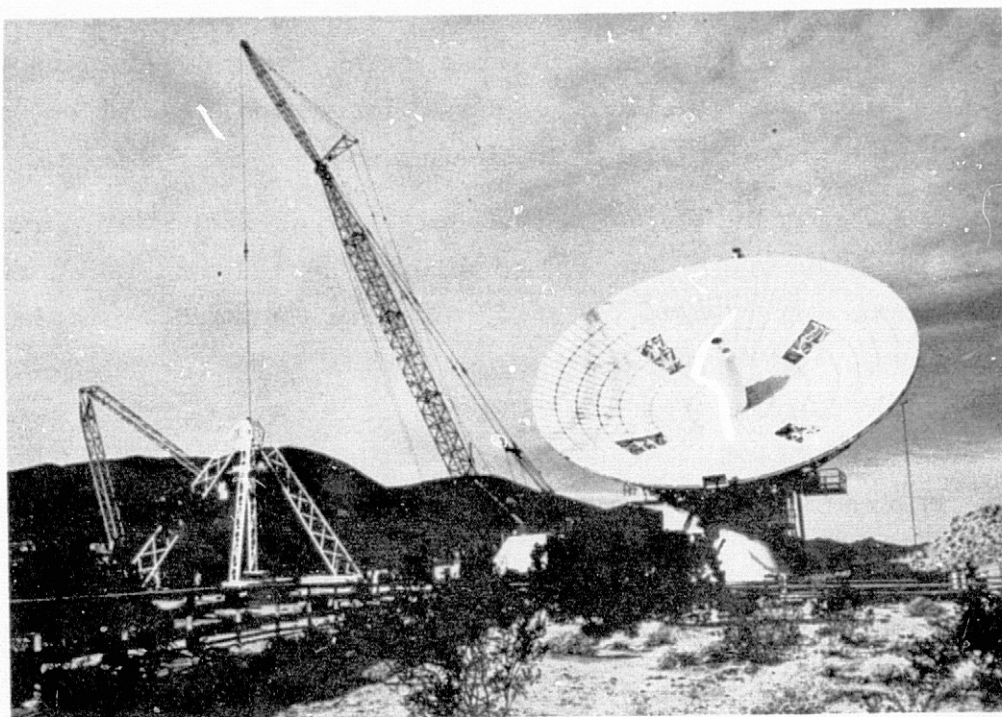
Figure 14. DSS 13 subreflector installation

¹⁵ Examination of Figure 14 frequently raises the question: did the crane boom, cables, et al. intercept the transmitted beam, and if so, were noise bursts and/or intermodulation products generated? It did, and they were.

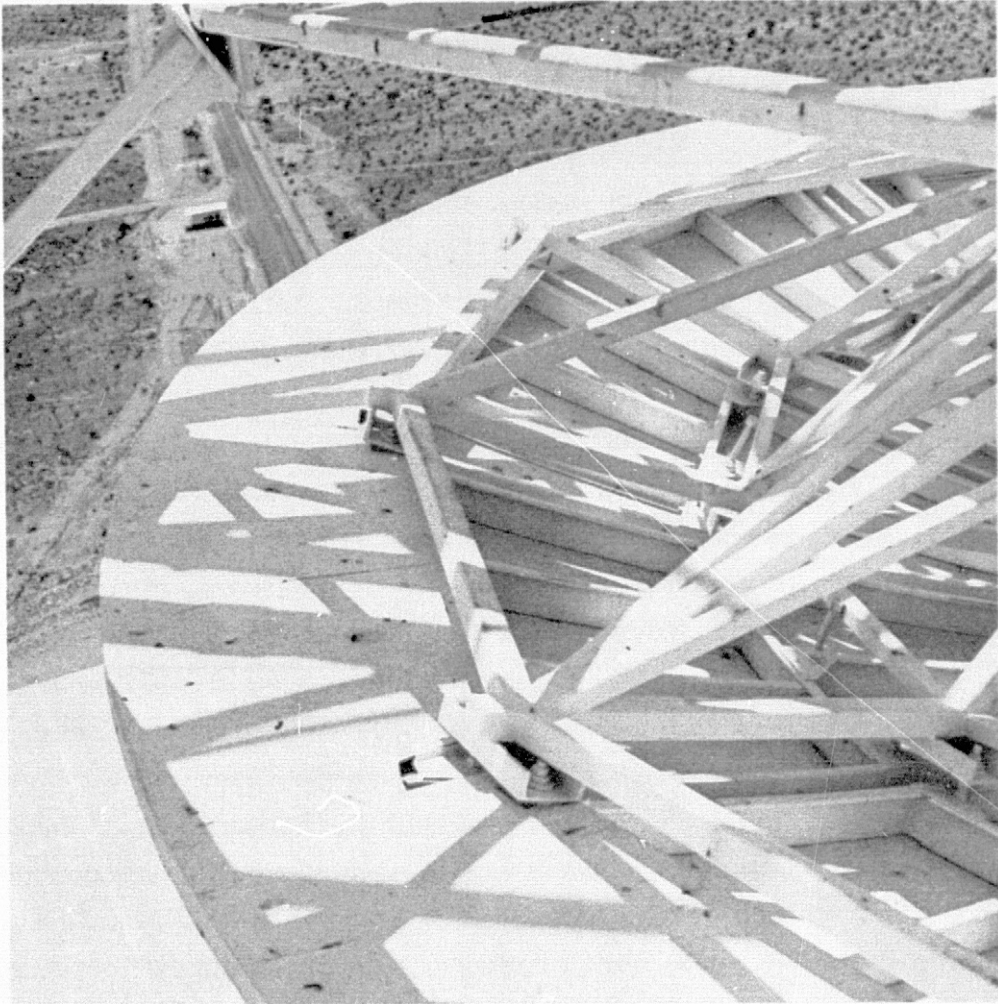
Figure 27. All-welded subreflector diffraction shield DSS 14

(1) Work Done. At the apex, after finding that the aluminum tape repairs to the subreflector seams had fractured, the subreflector was removed to the ground and all seams in the reflector surface welded. An all-welded diffraction shield was added to the backside perimeter of the subreflector, thereby providing a reliable conductor over a radial distance of at least 2 wavelengths on the "twilight" side (Figure 27). Additional structural joints were welded that were located outside of the subreflector shadow zone (defined to be a vertical cylinder extending above the subreflector and roughly 2 meters less

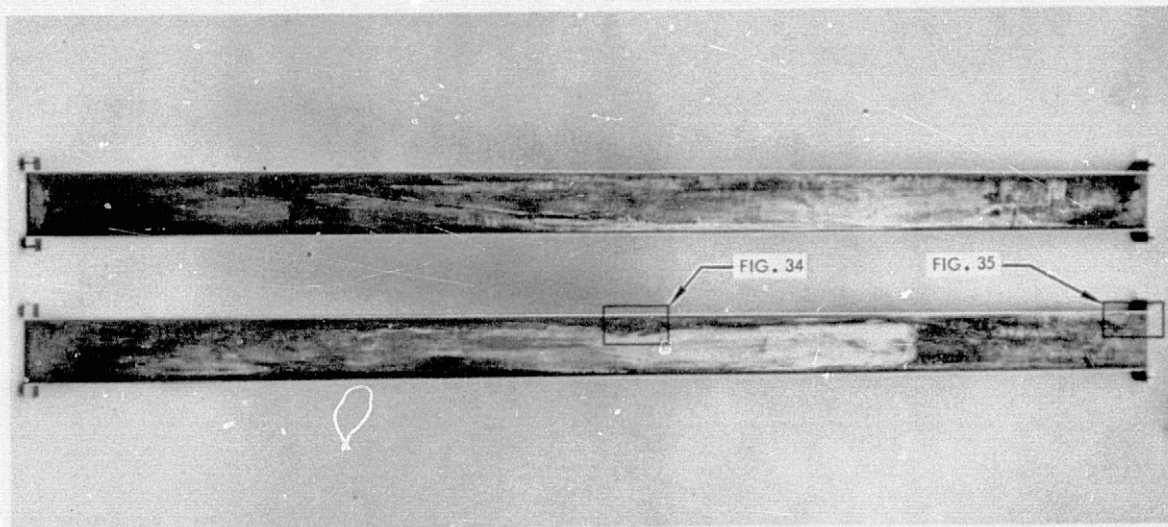
Figure 33. Long waveguide, longitudinally parted with closeup areas

²⁶ Visual inspection, achievable only after the part had cooled, did not immediately reveal the chip. This was in part due to the long length of the waveguide (2-3 meters), but further, this chip behaved in a bimetallic manner, and retreated flush with the surface upon cooling. Subsequent checking of other waveguides revealed several additional such chips.
